Testimony

I am Gerald R. Brown, Labor & Industries Public Safety Elevator Program Manager, AHJ and Chief Elevator Inspector for the State of Washington. I am here to speak against the proposed changes to fire life safety as it pertains to the elevator riding public. There is a long standing requirement found in the NFPA 13 -"Standard for the Installation of Sprinkler Systems" Section 9.3.6.3 that is there to provide a level of safety being overlooked recently with an Emergency Ruling CR-103E to eliminate crucial fire sprinklers located in elevator pits and machine rooms. Along with the requirement for Shunt Trip breakers which remove power from the elevator system after it has been safely returned to the main lobby floor by the smoke detectors, and placed out of service after the passengers have exited. The rationale listed in the justification doesn't consider the changing elevator technology of products being installed in Washington State after the latest rule change from Oct. 1, 2021 which allows machine-room-less hydraulic elevators which have the oil tanks in the hoistway and pit. The pit hydraulic tank with several barrels of flammable hydraulic oil is located 6 inches below

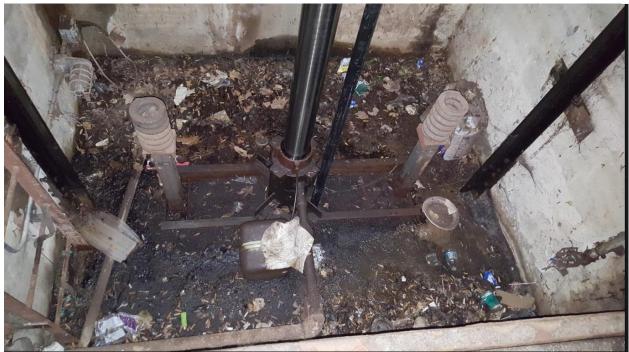
Elevator Pit Photos examples typical, bad, and worst. ALL WOULD BURN;

NFPA Flammability rating for Elevator hydraulic oil is given a 1(one). What this means is that elevator hydraulic fluid is actually flammable if it's heated up. What the concern is if a dirty elevator pit debris or paper records in the machine room catch fire, the exposed film of oil will heat up and cause the oil to burn. In an enclosed elevator hoistway the riding public is standing on a plywood floor and inside a ventilated cab that would allow toxic smoke to fill their lungs. The elevator pits are constantly accumulating paper and other flammable debris. The elevator service techs are only there quarterly or semiannually to service the equipment and check the pits. Hydraulic elevator pistons that move the car require a slight film of hydraulic oil to move freely. Each trip leaves more oil that goes into a catch cantainer in the pit. Typical elevator pits have a heavy film of oil that gathers on the pit floor along with oil saturated paper etc. I have photos of elevator pits with varing degrees of debris.
